Manhole Inspection Summary

Manhole # S41I2_001MH

Location Address: **Across from 4603 Virginia Ave.**

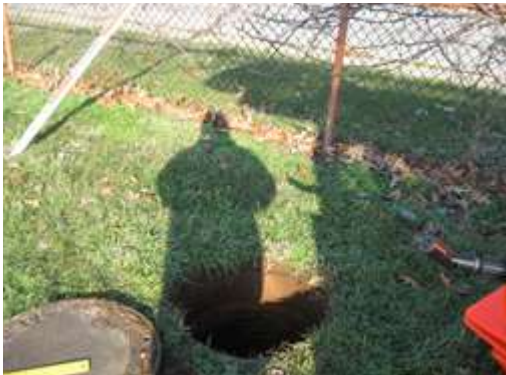
Location View

Virginia Ave baseball fields

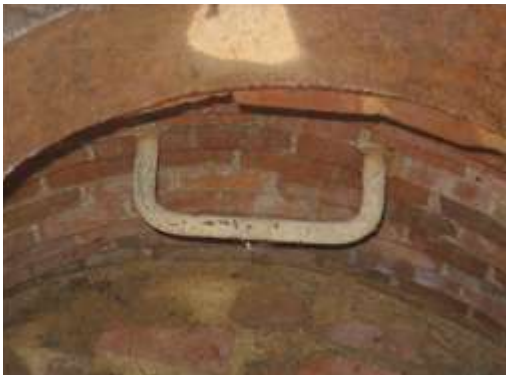
steps

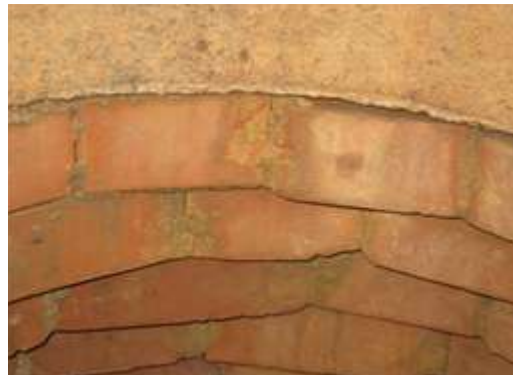
Defect 1

Infiltration: ☐ None ☒ **Joint** ☐ Cracks ☐ Mortar ☐ Roots ☐ Wall

Infiltration from frame-chimney joint

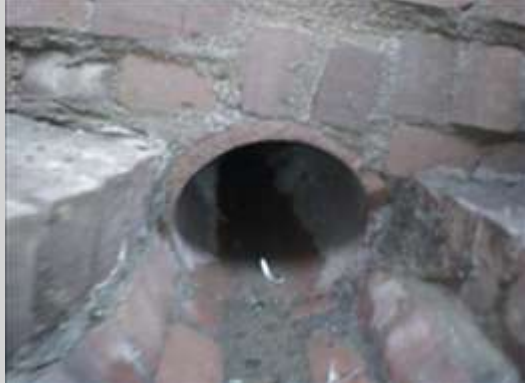
12 O'Clock Outflow

8 in. Circular Gravity Sewer
Pipe Out @ 12 O'Clock

Pipe Height: **8.4** (in.) Rod and Bar (Angled)
Pipe Material: **Clay** ☐ Pipe Lined
Invert Depth: **5.36** (ft.) Flow Characteristics: **None**
Deposits: ☒ None ☐ Mud ☐ Sludge ☐ Debris ☐ Grease
Silt Depth: (in.) Deposits Extent:
Infiltration: **None** Pipe Seal Cond: **Sound**

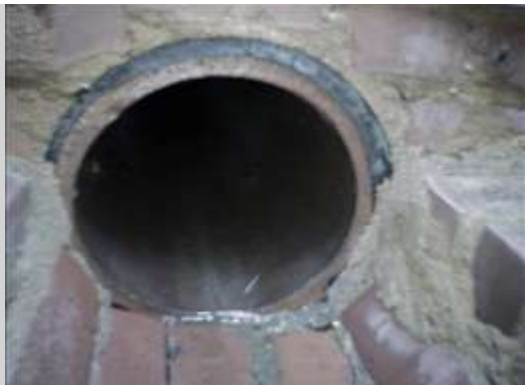
7 O'Clock Inflow

8 in. Circular Gravity Sewer
Pipe In @ 7 O'Clock

Pipe Height: **8.4** (in.) Rod and Bar (Angled)
Pipe Material: **Clay** ☐ Pipe Lined
Invert Depth: **4.78** (ft.) Flow Characteristics: **None**
Deposits: ☒ None ☐ Mud ☐ Sludge ☐ Debris ☐ Grease
Silt Depth: (in.) Deposits Extent:
Infiltration: **None** Pipe Seal Cond: **Sound**
